2013 & 2014 UAS Seabird Survey Test Flights Draft Report
Sue Thomas, USFWS Washington Maritime Refuge Complex
10/8/14

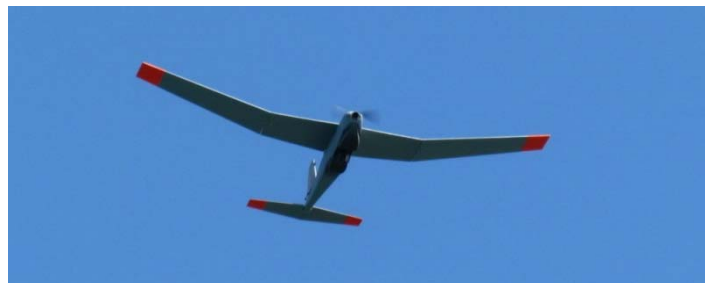
Two UAS units were tested in this project: the Puma and QuadraCopter. The Puma is a small fixed-wing version of UAS owned and operated by NOAA. Like most UAS, the Puma was designed to emit minimal noise. During recent test flights, the Puma was undetectable to multiple sound meters beyond 30' AGL except on takeoff when a range of 68-85 dBA was detected. The Puma is equipped with a camera that is a proprietary design by the UAS manufacturer AV. The EO camera is 5 megapixels with a 31.5 degree field of view and transmits video at 30 fps at a resolution of 640x480 pixels. The IR camera has a 24.6 degree field of view and transmits video at 30 fps at a resolution of 640x480 pixels. The battery capacity will allow for 1.5 hours of flight time. With 4 batteries available, up to 6 hours of flight time is possible in one day. For more information go to: http://www.avinc.com/uas/small_uas/puma/.

The Puma cannot operate in winds greater than 25 knots. In addition, rain can impede the air speed indicator portal which will effect navigation. Optimum speed ranges from 20-40 knots, however a head or tail wind can increase or decrease speeds considerably. FAA restrictions require that the Puma remain within 1 mile of the pilot and within sight at all times. For inshore operations the FAA also requires the cloud ceiling to be >1,000' and visibility > 3 miles. If the unit is to be landed on the water, the sea state must be calm enough for landing (less than 15 knots wind, swell less than 4-6' and period of 12 seconds or more) which can vary depending on boat dynamics & availability of a lee behind an island. The Puma team was primarily located onboard the S/V Tatoosh. Vessel restrictions include no more than 10 people near shore and no more than 6 people offshore. It can cruise at approximately 24 knots with a limit of 25 knots of wind with 6 foot swells under ten seconds.

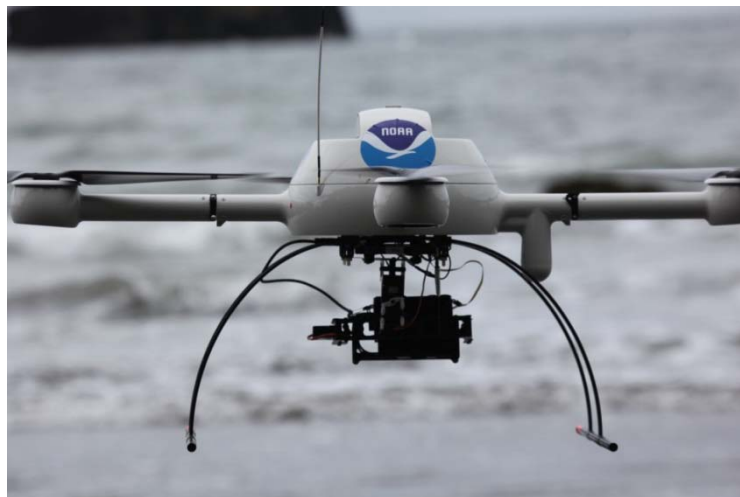
The QuadraCopter (Md4 – 1000) is a small helicopter version of UAS. Optics on the QuadraCopter provide a higher video quality with a 24 mega pixel camera when compared to the Puma but it must be launched from land. The distance in which the download link is effective essentially limits the range of the unit to 720m or 0.4 miles from ground operations. The camera can be operated in still or video mode but not both. Flight times range from 10-15 minutes followed by 40 minutes to 3 hours to recharge the battery. Flight speed ranges from 20-40 knots however; at only 12 pounds winds buffeted the QuadraCopter quite a bit causing

the video footage to be jumpy. The unit operates effectively at 12 knots of wind with a maximum of 20 knots. FAA restrictions require that the Quadcopter remain within 0.5 miles of the operator and maintain an altitude of 300' AGL or lower. In addition, pilots must have >1,000' ceiling and over 3 miles of visibility to operate the Quadcopter. This battery-powered unit emits less than 68 dBA of sound hovering at 3 meters AGL. This sound rapidly becomes imperceptible above 3m AGL. In addition, downdraft is negligible causing no movement of grass directly below the Quadcopter hovering at 2 meters AGL. For more information, go to: <http://microdrones.com/products/md4-1000/md4-1000-key-information.php>.

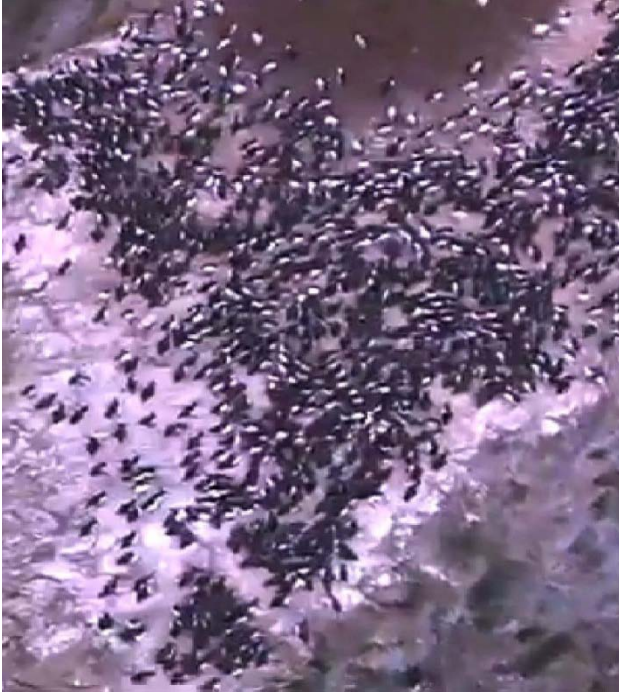
Still frame grab from video footage in VARS taken during post processing (orig 5.94M prior to crop). Not countable.

IMAGE QUALITY - Due to bandwidth limitations in the downlink, the avionics compress the video down from the 5 MP resolution. Additional image quality was lost while converting from a mpg to a mov format for VARS (Video Annotation Reference System; used by OCNMS to analyze underwater footage). As a result, the image quality was reduced to such an extent that counting birds using the still frame or video footage was not possible. Also, since the current footage/software does not have the capacity to zoom in, gulls or cormorants on the nest cannot be distinguished from those roosting nearby. Below are some still images that are comparable to the video footage for comparison of image quality.

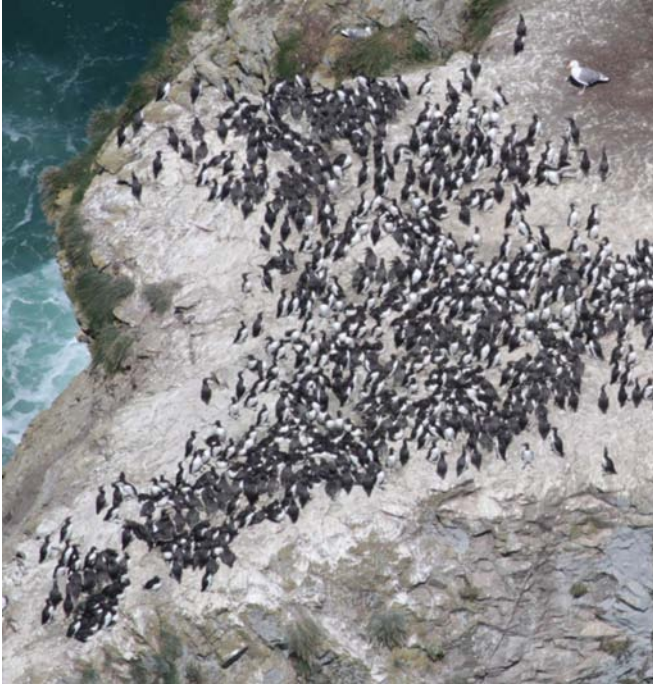
Still frame from Helo surveys (60.2M).
Countable.

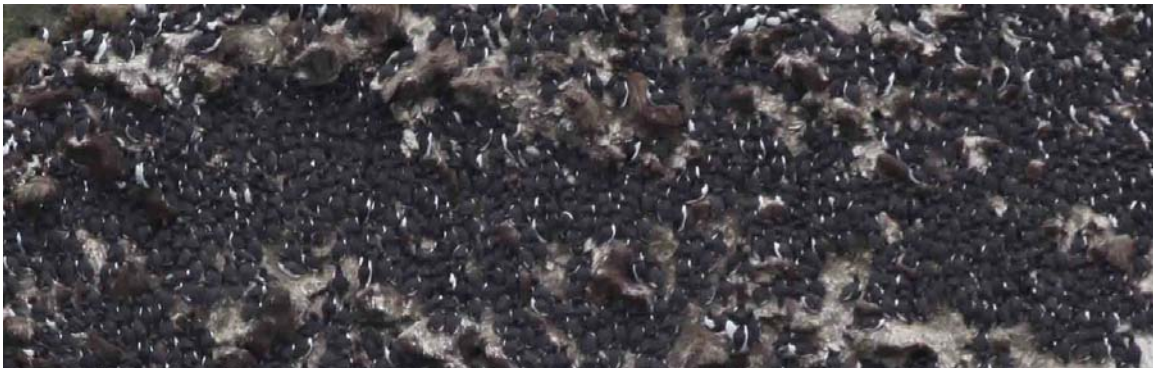
IMAGE QUALITY - Ultimately any imagery must be of high enough quality to zoom in and count murres in dense clusters often found in areas of varying micro topography or under ledges. Still frame shots processed in a geodatabase remain the data standard for the surface nesting seabird survey and the best option to count such dense, complicated clusters. Video is much too fast and choppy and does not yet provide the quality of imagery to either pause or take still frame grabs for counting.

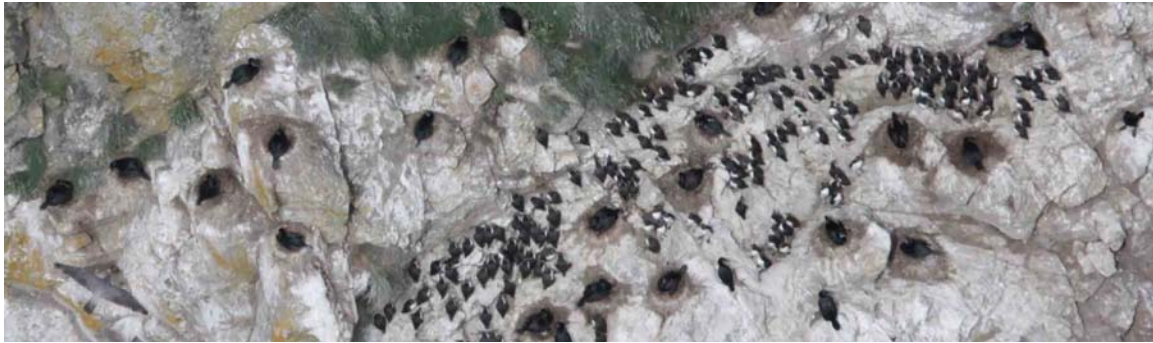
In addition, imagery must be of high enough quality to zoom in to and differentiate between different types of nest materials for identification and counting of cormorants. Only cormorants

and gulls on nests are counted and often the difference between two (one of high conservation concern and another proposed for population management) is the type of nesting material.
